**NASA
Technical
Paper
2884**

**Cyclic Loads Tests of
Carbon Involute Solid
Rocket Motor Outer
Boot Ring Segments**

Rafiq Ahmed
*George C. Marshall Space Flight Center
Marshall Space Flight Center, Alabama*

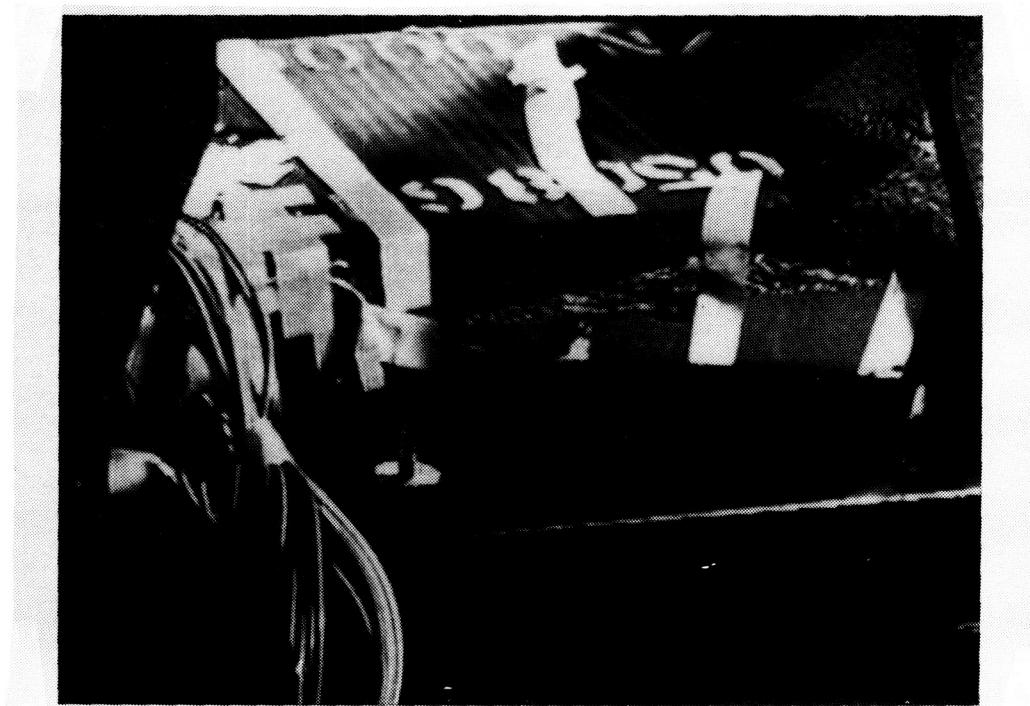
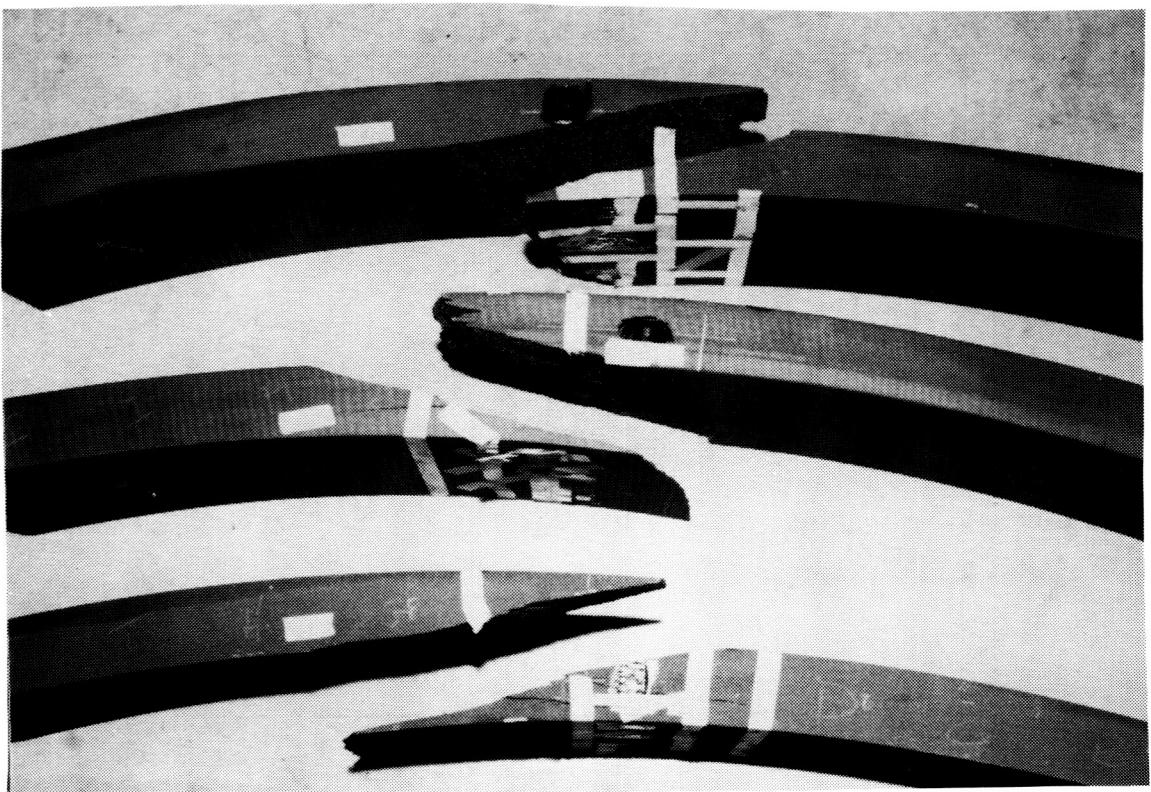
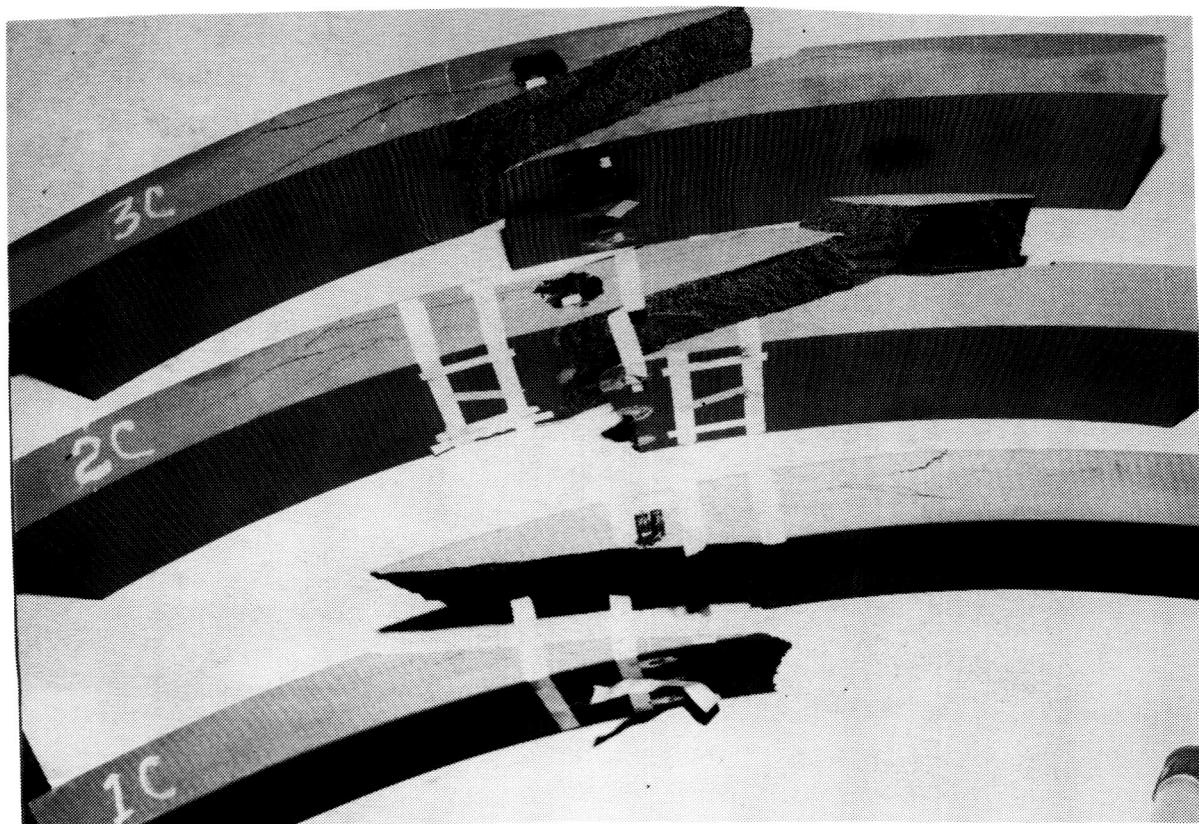
Fiber failures and delaminations were noticed in the failures of all specimens. Fiber breakage occurred primarily on the tension side of each specimen except No. 5, while delaminations occurred mostly on the compression side. This happened because the compressive fiber strength of the material is much greater than the tensile strength; therefore, the compressive-side material tended to peel away during failure.

Specimen Nos. 4, 5, and 6 showed significant secondary cracking through the thickness of the segment, apparently caused by the cycling routine imposed on each. The matrix, but not the fibers, seemed to have been degraded by cycling, thereby facilitating crack propagation. The secondary cracking may also account for the unique tension-side delamination in Specimen No. 5.

The failure surfaces of each specimen are shown in Figures 21, 22, and 23.

Figure 21. Test setup after failure.

Figure 22. SRB 30-in. segment cyclic load test, uncycled specimens.

Figure 23. SRB 30-in. segment cyclic load test, cycled specimens.
